• EXHAUST SYSTEM—LOOSE CATALYST OR MUFFLER HEAT SHIELDS

• NOISE—"BUZZING" OR "RATTLING"—LOOSE CATALYST OR MUFFLER HEAT SHIELDS

Article No. 98-20-10

FORD: 1993 FESTIVA

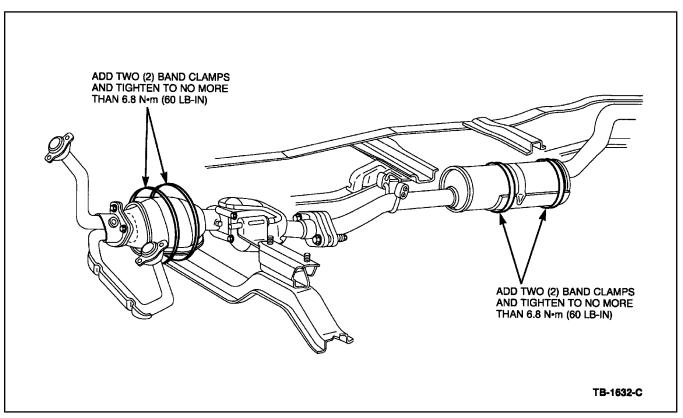
Figure 1 - Article 98-20-10

A "buzzing" or "rattling" noise from the exhaust system may be caused by a loose heat shield attachment to the catalytic converter, catalytic pipes, muffler pipes and/or muffler. The noise is noticeable during normal driving conditions or at engine idle.

- Install worm clamps to the catalytic converter, catalytic pipes, muffler pipes or muffler as shown in Figure 1 for the typical light truck and Figure 2 for the typical passenger car.
- 3. Align the clamps to secure the heat shield to the catalytic converter, catalytic pipes, muffler pipes or muffler as required.
- 4. Tighten the clamps to 6.8 Nem (60 lb-in).
- 5. Trim the excess "ear" of the clamp to approximately 2.54 cm (1").
