SUSPENSION—VEHICLE LEAN LEFT—ALL MODELS EXCEPT LIMOUSINE

Article No.
91-22-2

LINCOLN: 1991 TOWN CAR

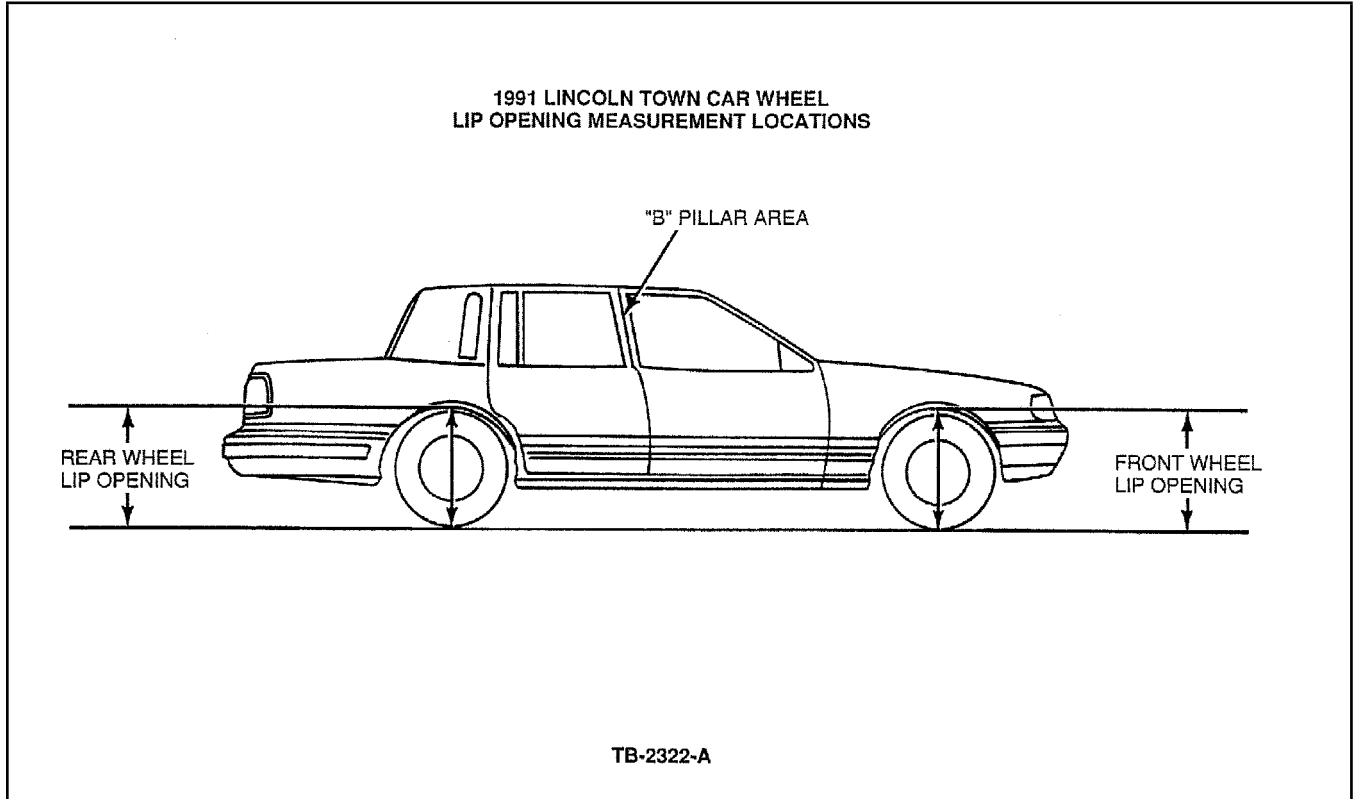
Figure 1 - Article 91-22-2

4. Equalize the suspension by shaking the vehicle side-to-side from the "B" pillar joint before taking wheel lip measurements, Figure 1.
5. Determine the difference in the front and rear wheel lip measurements by subtracting the left side measurement from the right hand side at both the front and rear locations.

THE FENDER WHEEL LIP MEASUREMENT IS THE VERTICAL DISTANCE FROM THE FENDER WHEEL LIP TO THE GROUND WHILE PASSING THROUGH THE CENTER OF THE WHEEL, FIGURE 1.
