SUSPENSION—VEHICLE LEAN RIGHT—ALL MODELS EXCEPT POLICE

Article No.
97-18-2

FORD: 1995-1997 CROWN VICTORIA

LINCOLN: 1995-1997 TOWN CAR

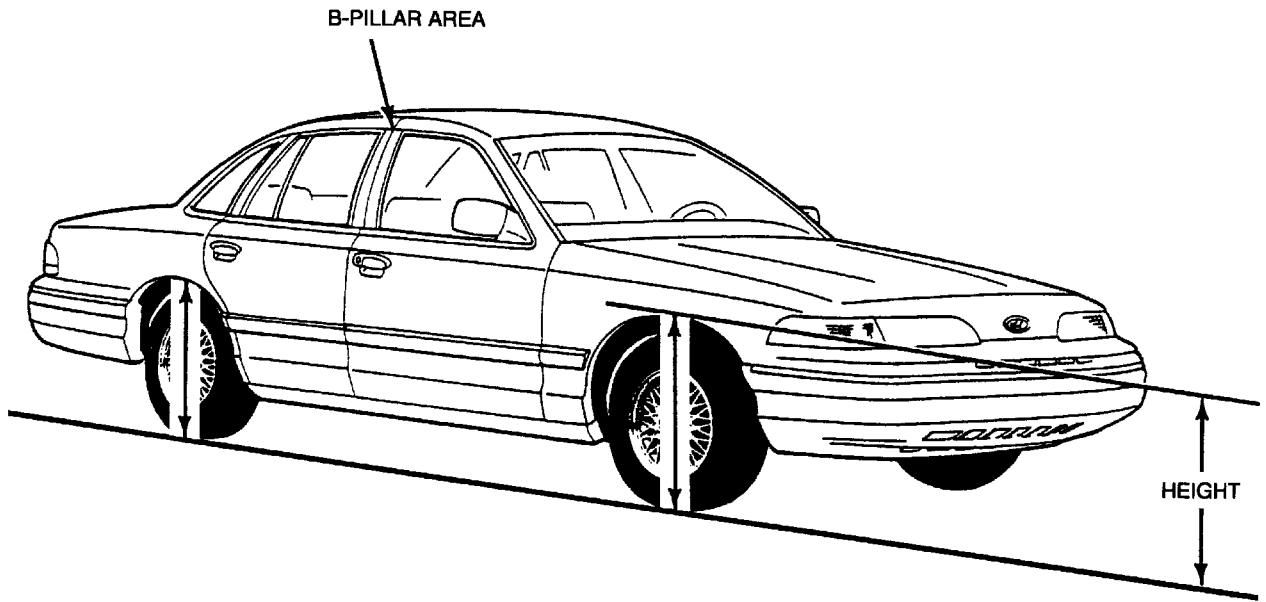
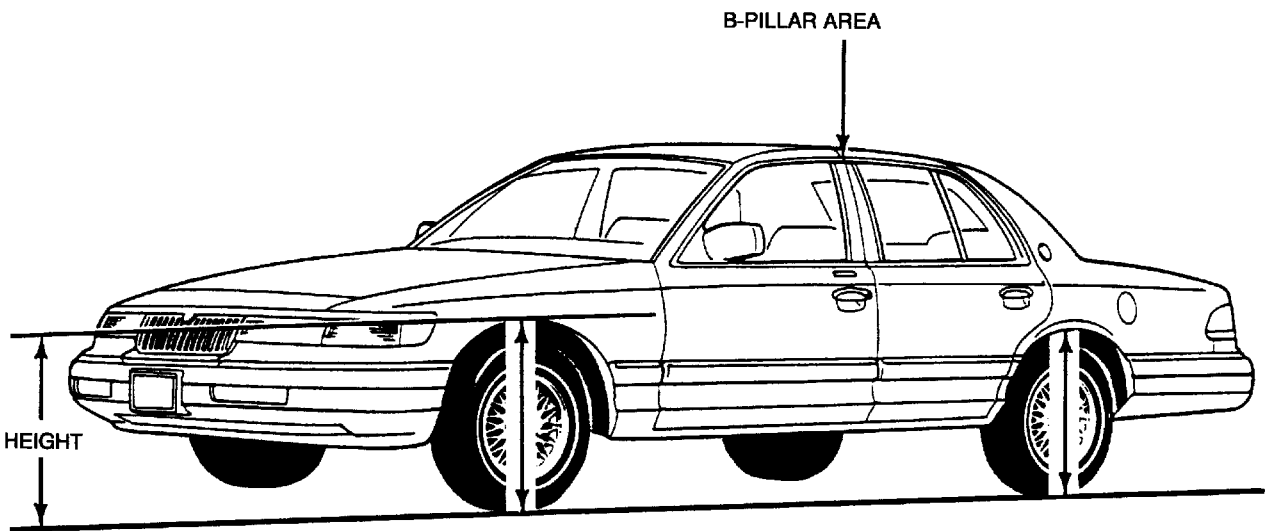
Figure 1 - Article 97-18-2

A lean right condition may be present on some vehicles. This does not include Police units. The lean may be caused by vehicle weight side-to-side differences from component packaging, body shell and frame tolerances.

6. Equalize the suspension by shaking the vehicle side-to-side from the B-pillar joint before taking wheel lip measurements (Figure 1).

THE FENDER WHEEL LIP MEASUREMENT IS THE VERTICAL DISTANCE FROM THE FENDER WHEEL LIP TO THE GROUND WHILE PASSING THROUGH THE CENTER OF THE WHEEL (FIGURE 1).

9. Using the three letter code on the driver's side front spring, replace the steel spring with a part with load rating one level lower. Replace the right front spring with part with load rating one level higher (swap springs side-to-side).

11. If this procedure does not reduce the lean to acceptable levels of 12.7mm (0.5"), refer to TSB 93-1-1 for the body/frame shimming procedure. This procedure may be performed to further reduce the vehicle lean condition.
12. Verify vehicle alignment is within specification after completing repairs.
