Ford Motor Company

Subject: PE04-010:NVS-214jry

Attached is the Ford Motor Company (Ford) response to the agency's March 3, 2004 letter concerning reports of alleged rear axle shaft wear and/or allegations of axle shaft fracture at the outer bearing interface on 2003 model year Ford Crown Victoria, Mercury Grand Marquis and certain Lincoln Town Car vehicles.

FORD MOTOR COMPANY (FORD) RESPONSE TO PE04-010

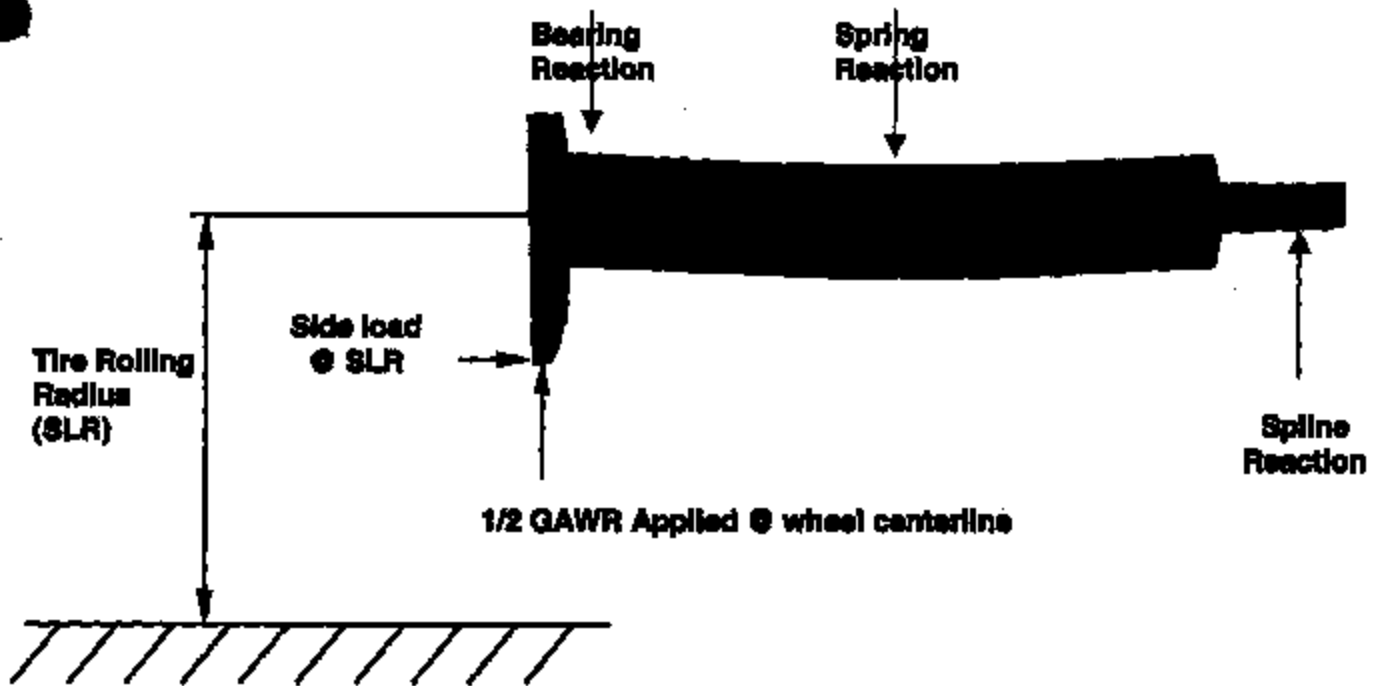
Figure 1, Axle Bending Under Cornering Load
