Ford Crown Victoria

Cruise Control Installation & Troubleshooting

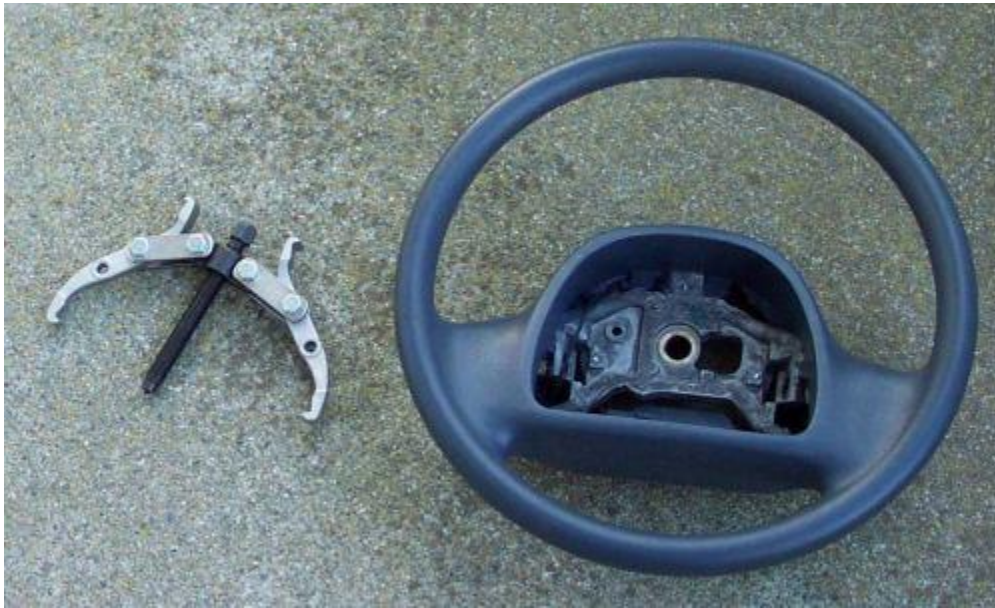
Picture of the original non-cruise steering wheel installed in my 98' PI, the tool to the left is the two jaw puller used to remove the steering wheel from the column.

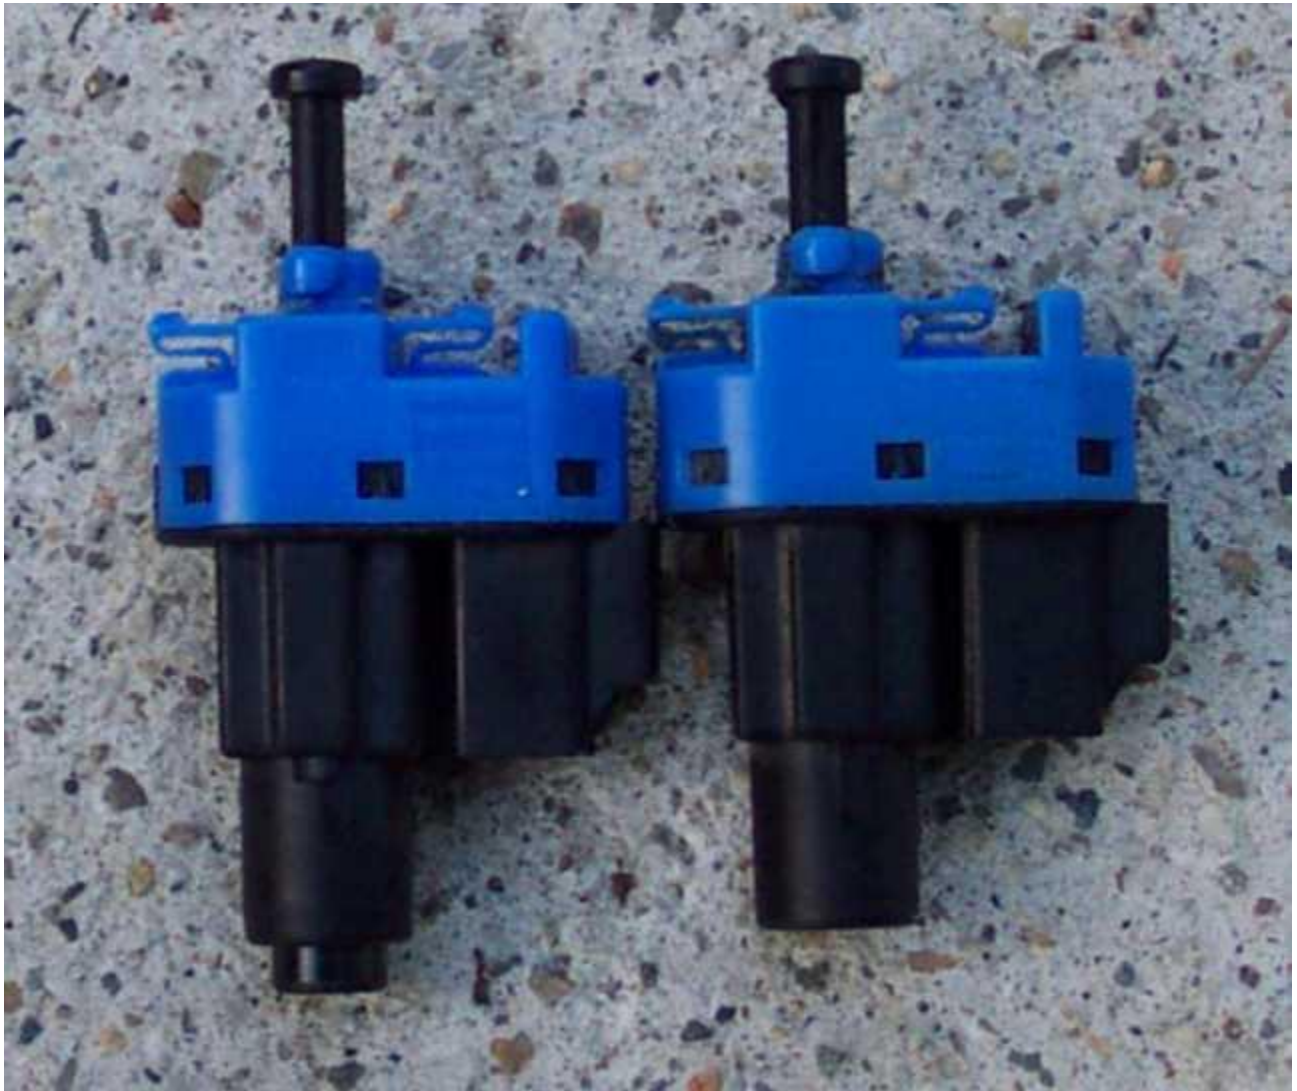
And here's a closeup of the speed control deac switches from a 98' crown victoria and a 01' grand marquis

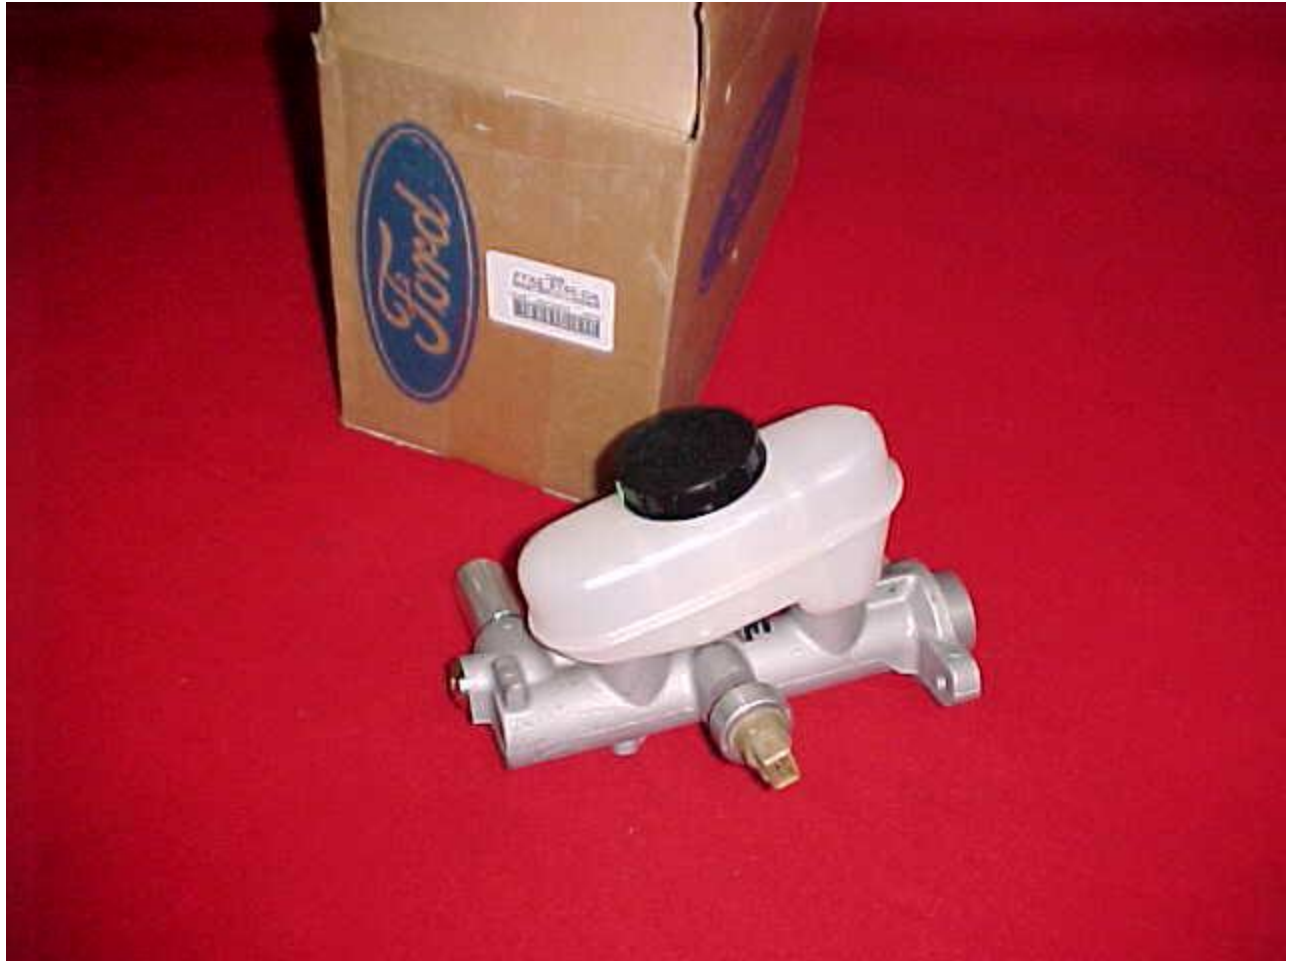
Note the electrical connector on the sensor mounted to the metal housing of the master cylinder, that's the brake pressure (DEAC) switch used in 1996-1997 crown victorias. Some 1992-1997 crownvics will instead have the deac switch located on the proportioning valve below the master cylinder.

- On the old 92-97 vehicles, carefully inspect the speed deac switch mounted to the brake master cylinder. If it fails, it can cause the speed control system to become inoperative. It could also vent the hydraulic system to the outside air which could turn into an expensive repair should significant amounts of water or other debris accumulate inside the abs hydraulic control unit. As mentioned previously, 98+ vehicles use a switch mounted to the brake pedal box inside the car instead of the master cylinder under the hood.
